Building Performance: Basement Buildings and Urban Flooding

Hurricane Ida NYC MAT Technical Report 1

June 2023

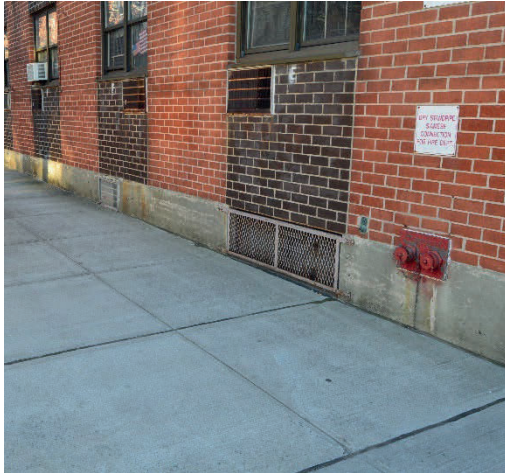
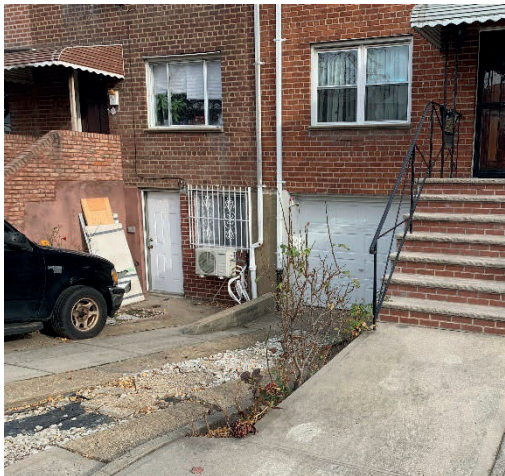
a. Ventilation openings near sidewalk level

b. Basement window sill near sidewalk level

c. Driveway sloping down to converted basement

d. Basement stairway threshold at sidewalk level

Figure 5. Examples of points of entry for surface flooding

In some one- and two-family dwellings, water entered below-grade garages after street flooding reached the crests of driveways (Figure 5c). In others, it flowed down exterior basement access stairs as floodwater crested the stairway threshold (Figure 5d). Rectangular “slot” drains were observed at the base of driveways for many homes. Floor drains were seen at the base of the access stairs to many basement spaces, but most did not have sump pumps. These drains are intended to divert incoming water to the stormwater drainage system, with or without pumping. Team observations suggest that operating sump pumps could help limit accumulation of runoff from limited areas of driveways, access ramps, and exterior stairs. Most sump pumps installed in dwelling basements may have adequate capacity to remove some accumulated water. However, the typical sump pump is not designed for the volume of water that crested ramps and driveways and overtopped basement stairs, flowing into and filling many basements.

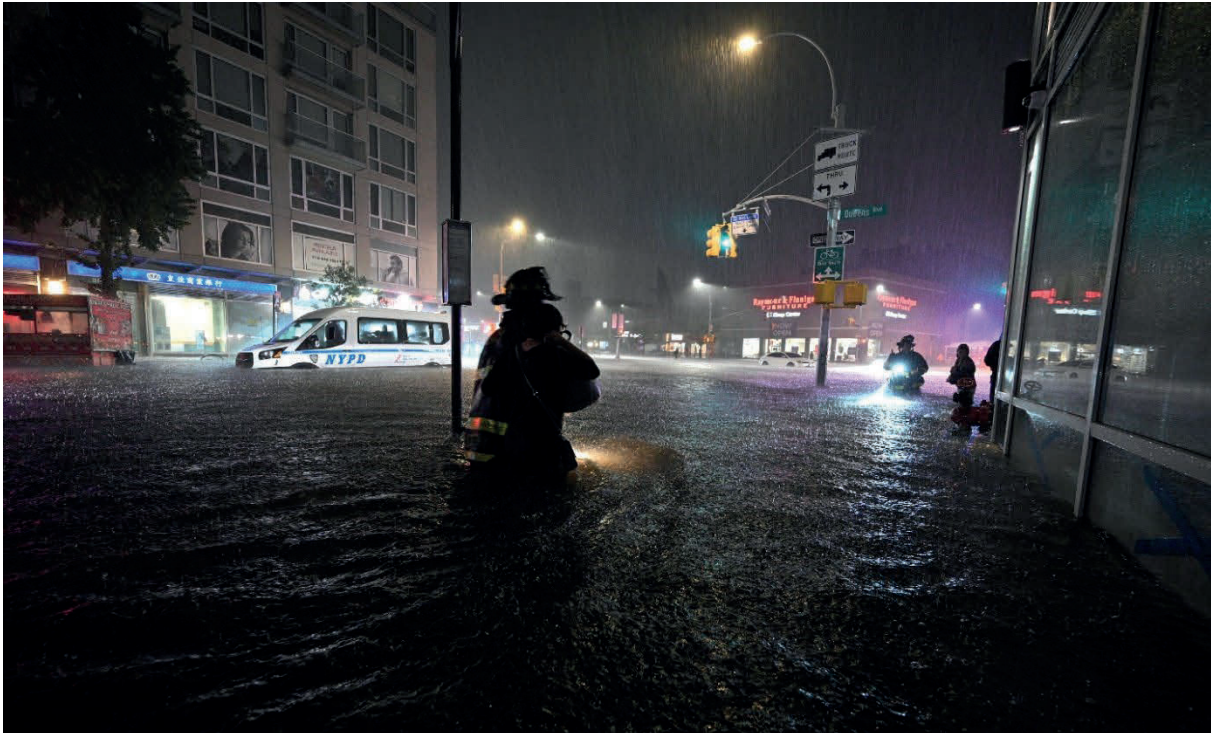
Figure 11. Street flooding caused by the remnants of Hurricane Ida

The rainfall runoff during the storm overwhelmed the stormwater drainage system in many parts of the city. This resulted in the accumulation of surface water on roadways and sidewalks, particularly in lower lying areas (Figure 11). In some areas, the runoff overtopped curbs and entered many building basements and below-grade areas.
